febi 33044

Opel 2.0 I Turbo and
2.2 I petrol engines

Chain tensioner

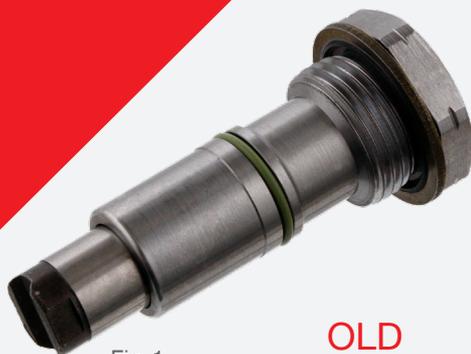
Fig. 1

OLD

Although all the components have been correctly fitted, rattling noises are often present (caused by the elongation of the timing chain). If the timing chain slips as a result, then the engine can run erratically and misfire and in the worst case cause extensive engine damage. This affects Z22YH and Z22SE engines.

A blocked timing chain tensioner. The original version (repl. no. 0636549) of the chain tensioner had a green O-ring and a rubber-lined washer (see Fig. 1). The vehicle manufacturer fitted this version in the engines mentioned above. A modified chain tensioner has been used in production since model year 2009.

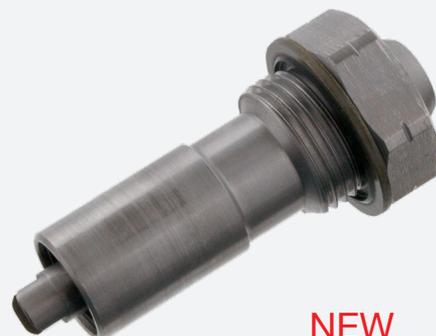
Fig. 2

NEW

febi recommends using only the new chain tensioner febi 33044 (repl. no. 4807 839). This is provided with a rubber-lined metal washer under the head (see Fig. 2). This ensures perfect guidance of the timing chain.

We always recommend that a new timing chain (febi 33043 repl. no is 5636 396) is fitted when replacing the chain tensioner. Both components are included in the chain kits febi 33042 (fits Z22YH) and febi 33045 (fits Z22SE)!
