SWAG 30 94 0321

To fit:
various Volkswagen, Audi, SEAT and Skoda models

Ignition coil

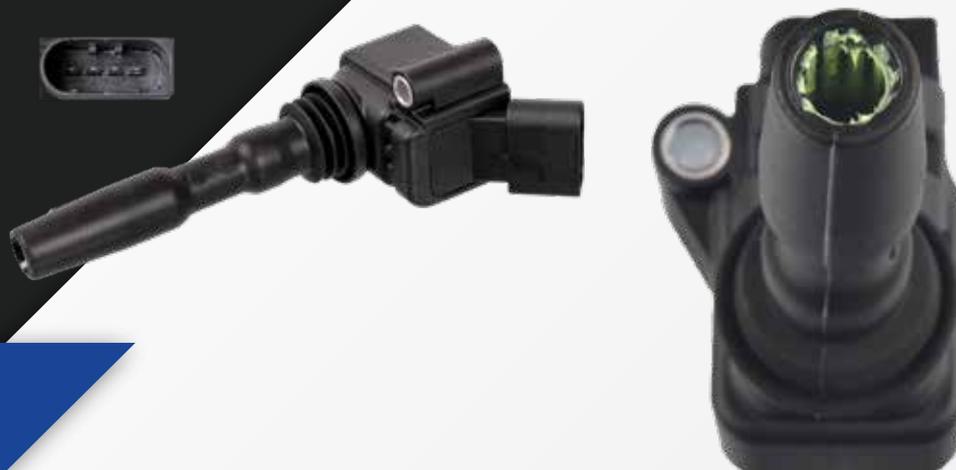
Figure 1

SWAG ignition coil 30 94 0321 is equipped with dielectric grease applied within the rubber insulation tube (Fig.1) which is non-conductive and eases the fitment of the coil as it is inserted onto the spark plug - therefore reducing the risk of it becoming 'bonded' to the ceramics of the spark plug for future repair and maintenance of the ignition system.

After removing the ignition coils from the cylinder head during the spark plug replacement process, carefully inspect the rubber insulation for any splits or damage that could lead to failure. This is highly recommended if the ignition coil has been subjected to excess force when trying to remove them. The coil should then be replaced to reduce the risk of ignition failure and ensure engine reliability.
