### Check actuator of intake port shutoff (IPS) - error messages are set incorrectly

**Vehicle Manufacturer:** Mercedes, Jeep Grand Cherokee, Chrysler 300

**Vehicle:** 280 CDI, 300 CDI, 320 CDI, 350 CDI

**Engine code:** OM 642.xxx, EXL

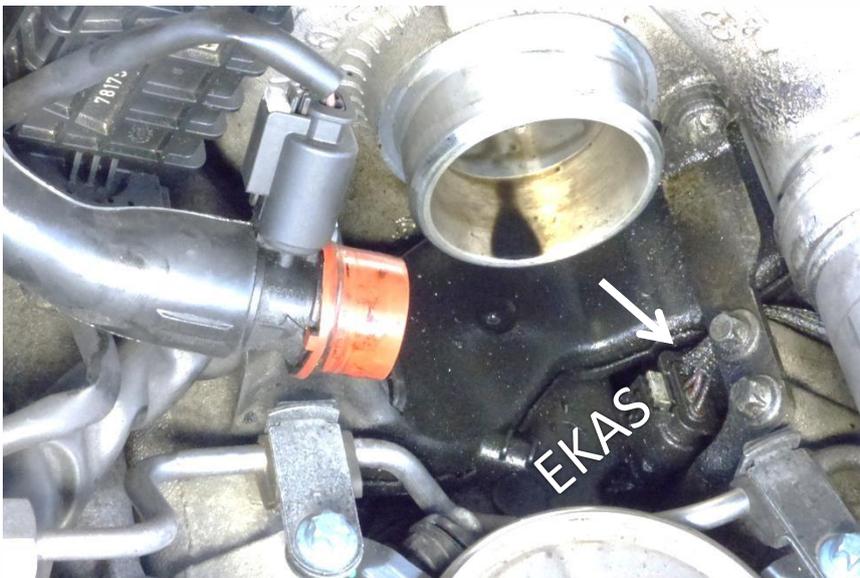
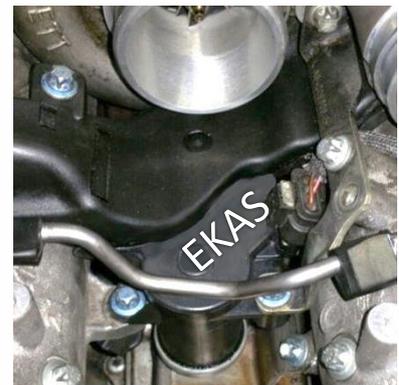
The actuator of the IPS may fail due to overload from crusted swirl flaps or mechanical defects. Leaking oil on the electrical connection leads to electrical errors on the actuator. Leakages in the intake area of the turbocharger or a leaking oil cooler leads to this oil contamination on the connector.

Oil accumulation in the intake duct of the turbocharger always originates from the crankcase ventilation. Check if the crankcase ventilation is working correctly and check the inner crankcase pressure. Use our BTS tool **MESS01** to do so.

Please check if the actuator of the IPS is moving freely and working without electrical errors. An overload on the IPS leads to drops in the power supply. IPS and boost pressure control of the turbocharger use the same power supply. Therefore, an electrical error on the IPS may lead to a wrong interpretation of errors by the ECU.
