### Error boost pressure control, power loss temporarily clamping VTG unit

**Vehicle:** Movano Mk II, Master III, NV 400

**Engine code:** M9T 678, M9T 680, M9T 694, M9T 696, M9T 698, M9T 880

**BTS reference:** T916619

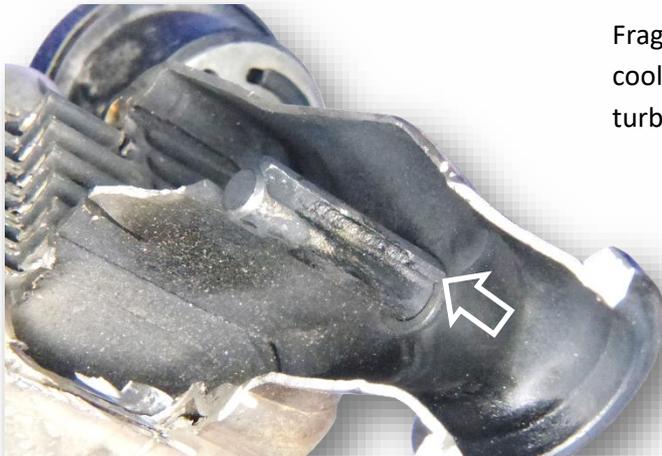
A malicious damage caused by an exhaust-side debris. This foreign body comes from a defective EGR cooler. Here often breaks the control valve, which is thrown back against the conventional exhaust direction in the exhaust manifold during the load change. From there, it finds its way into the turbine housing and destroys the VTG unit and turbine wheel.

Cut-open EGR cooler with broken control flap

In addition to the usual test work, the regulated EGR cooler must be checked for proper function and damage. In doing so, EGR pipes and exhaust manifolds should be inspected for foreign bodies. Damaged components have to be replaced.

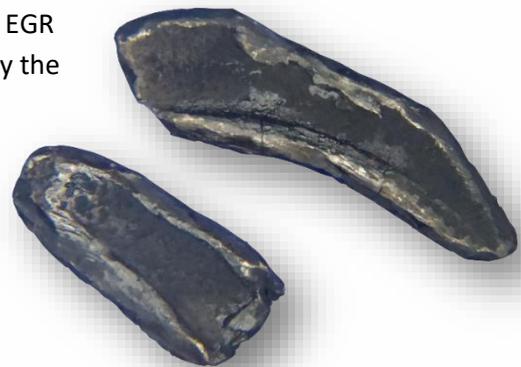
Fragments of EGR cooler destroy the turbocharger
