## INA Service Info

# Assembly instructions for tensioning pulley 531 0203 20

Manufacturers: Audi, Seat, Skoda, Volkswagen

Part no.: 531 0203 20  
 530 0171 10  
 530 0171 30

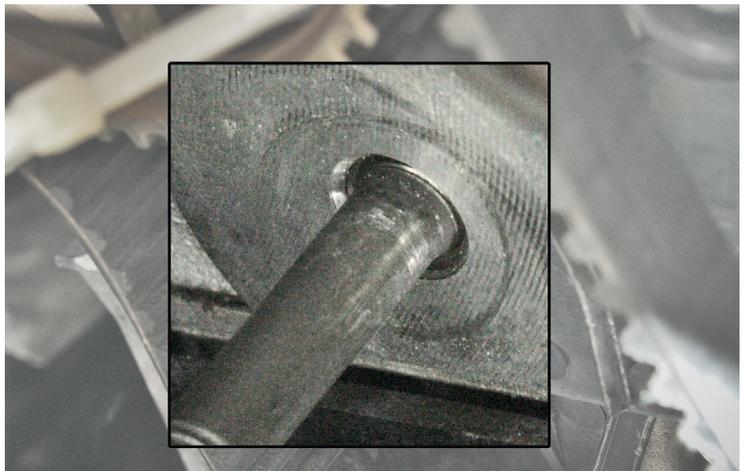
Image 2: The stud is correctly screwed in

When installing tensioning pulley 531 0203 20, you must ensure that the thread (M10) on the stud is fully screwed into and flush with the engine block. The thread must not protrude from the block (see Image 2).

You must ensure that the thread on the stud lies flush or below the engine block! If the stud is in any other position, this may cause the tensioning pulley to malfunction!

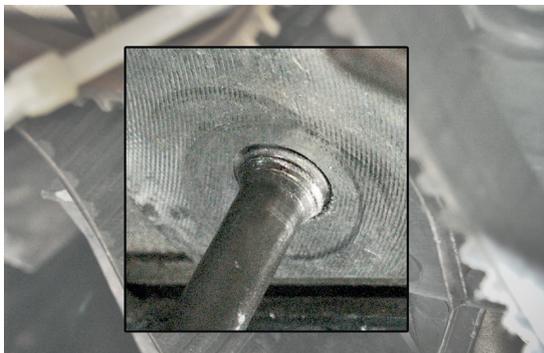
Image 1: The stud is not correctly screwed in

If the thread (M10) on the stud is not completely screwed in (see Image 1), the tensioning pulley does not lie flush with the surface of the engine block and will therefore become damaged. Tightening the tensioner onto the protruding threaded portion of the stud will give the impression that the tensioner is correctly clamped.

When the engine is running, the resulting forces in the tensioning pulley may cause the stud/tensioner to come loose, which could lead to major engine damage.
