## INA Service Info

# Defective toothed belt after a short run time

## Incorrect adjustment of the high-pressure fuel pump

Engines: DW 10 F  
 DW 12 R

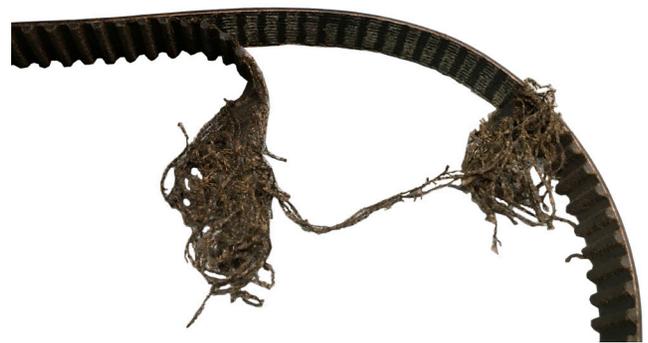
Image 1: Toothed belt with loosened tooth mesh

Following repair work on the cylinder head in the above engine variants, the toothed belt may exhibit severe wear after a relatively short operating time or the indicated damage profile (Image 1) may occur. It is noticeable that only a certain area of the toothed belt is affected. This damage is caused by incorrect adjustment of the high-pressure fuel pump during assembly.

If the high-pressure fuel pump is adjusted incorrectly, the short-term high torque requirements of both systems may overlap. In this scenario, the tensile load on the toothed belt often rises above the permissible value. The result is rapid partial wear, which damages the toothed belt within a very short time until it fails.

In such cases, the adjustment of the high-pressure fuel pump must be checked and corrected in accordance with the vehicle manufacturer's instructions.
