## INA Service Info

# Failure of the water pump

## Incorrect adjustment of the high-pressure fuel pump

Engines: DW 10 F  
 DW 12 R

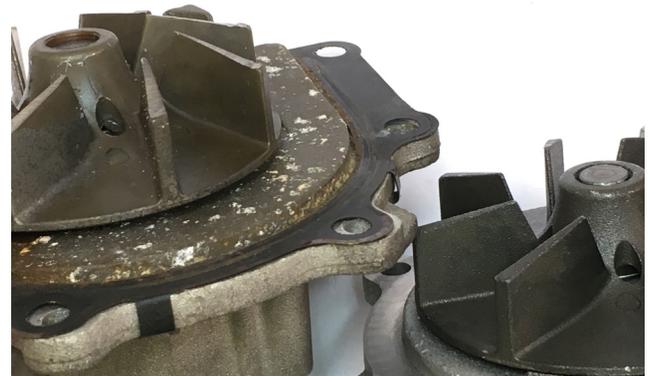
Image 1: Displaced impeller with scoring (left); correct position of the impeller (right)

Within a relatively short operating time after repair work on the cylinder head in the above engine variants, the impeller of the water pump may be displaced on the shaft (Figure 1) and work its way into the engine block. This damage is caused by incorrect adjustment of the high pressure fuel pump during assembly.

If the high-pressure fuel pump is adjusted incorrectly, the short-term high torque requirements of both systems may overlap. The resulting speed changes in the timing drive cause considerable vibration of the toothed belt. These vibrations cause the impeller to work loose from the shaft of the water pump, leading initially to noise and later to the water pump being blocked, which causes the toothed belt to fail.

In such cases, the adjustment of the high-pressure fuel pump must be checked and corrected in accordance with the vehicle manufacturer's instructions.
