## FITTING INSTRUCTIONS

### Transmissions systems

**Model for**  
Opel  
(gearboxes M32 & M20)

**Part numbers**  
804578 810016 810017  
810034 810039 810068  
810226

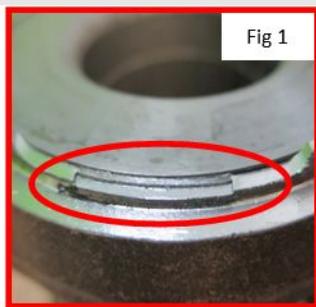
Unit returned has the back plate forced out; this is caused by the back plate not being supported by the gearbox mating face.

1. Before fitting the unit, **ensure the gearbox mating face is clean and clear from debris**. If it is not this can cause the unit to **sit unevenly on the gearbox (Fig 2)** giving the potential for the back plate to be **forced out by the hydraulic pressure (Fig 1)**.

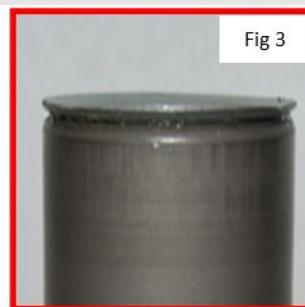
The piston retaining ring has deformation or rippling. This shows that the cylinder has been overstroked.

3. Check the hydraulic line for any defects or blockages. If the clutch pedal goes hard or does not return to its resting position after each depression during the bleeding process, **do not continue to try and bleed the hydraulic system**. Continuing to do so will result in too much fluid entering the fluid chamber within the CSC and will cause the piston retaining ring to move past its stopping point. **In Fig 3 you can see deformation/rippling. This shows that the cylinder has been overstroked.**

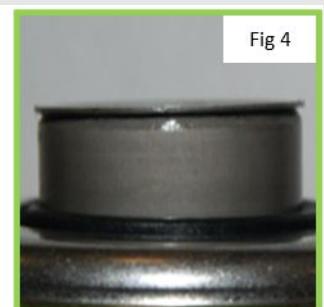
The piston retaining ring has no deformation or rippling. This shows that the cylinder has not been overstroked.

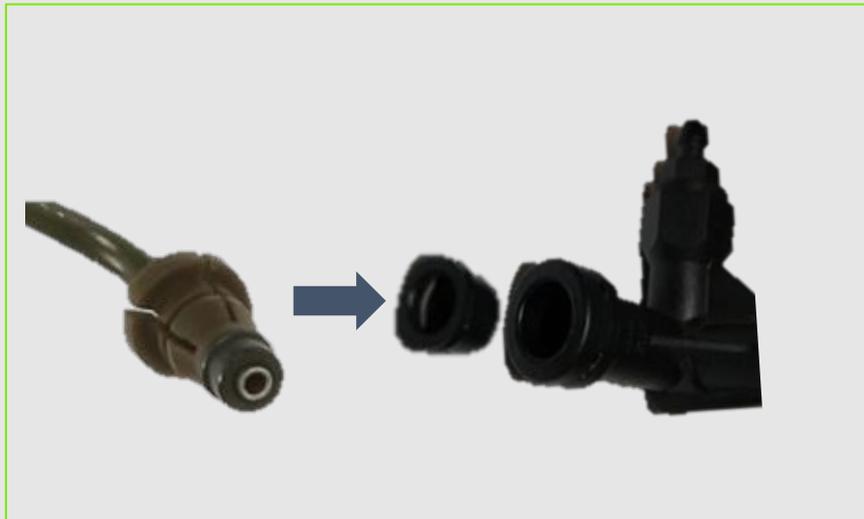
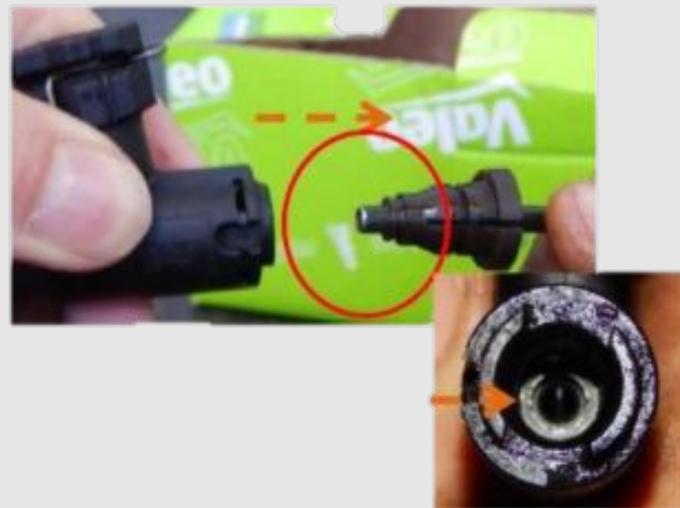
This issue is caused by a top hat seal located on the inlet/actuator pipe remaining in the female connector when the old unit is removed and/or the technician fit the new seal in the new CSC keeping old seal and new seal, this creates:

- A **one way valve situation** allowing fluid into the internal CSC chamber but not allowing it to return.
- **Over pressure** creating liquid leak and CSC breakdowns
  - The **fluid does not return**, too much fluid in the CSC will cause the bearing to over travel and force it past its end position and beyond the CSC retaining ring.

Subsequent depressions of the clutch pedal will fill the CSC until its full travel and a stiff pedal will occur. If this stiff pedal is overcome the CSC will over stroke and burst, necessitating a replacement.

**If the clutch pedal becomes hard, DO NOT depress the pedal further!**

**Ensure you removed the old seal from the pipe!**
