Technical *data*

Correct Tension Pulley Installation for Kits CT 1038 K1, CT 1034 K1, CT 989 K1 and CT 731 K1

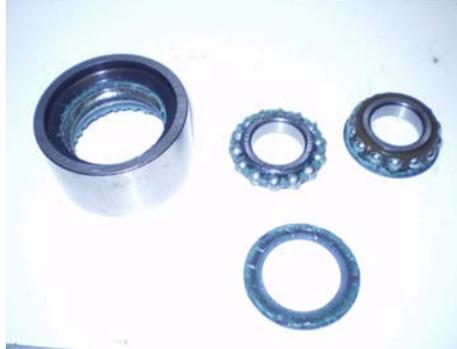
The tension pulley supplied with the kit breaks apart after a short period of operation, normally resulting in damage to the engine.

This is due to faulty alignment of the belt drive. The tension pulley is subjected to off-center loading and fails after a short running time.

Disassembled bearing

To ensure correct belt alignment, it is vital that the tension pulley holder is cleaned thoroughly, and that you subsequently check that the entire surface of the pulley is properly seated on the guide pin.

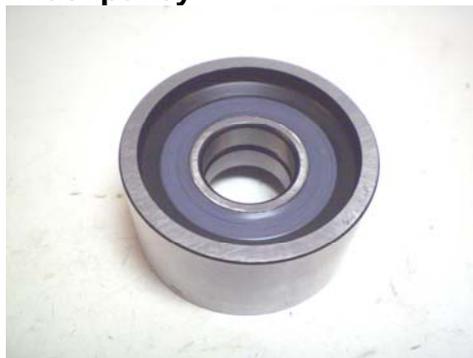
Intact pulley

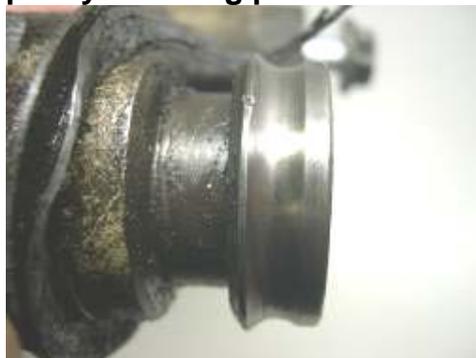
Guide pin of the tension pulley retaining plate
