Technical *Info*

Installation tips for tension pulleys: CT 870 K1, CT 873 K1, CT 975 K3 – Opel 1.4/ 1.6/ 1.8/ 2.0-16V

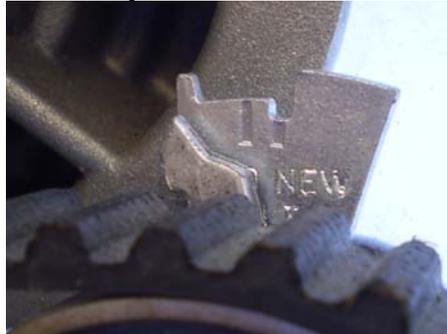
When cold, the pointer on the tension pulley no longer points to the mark and hits on the cold stop after each combustion cycle (noises).

Pointer position too low

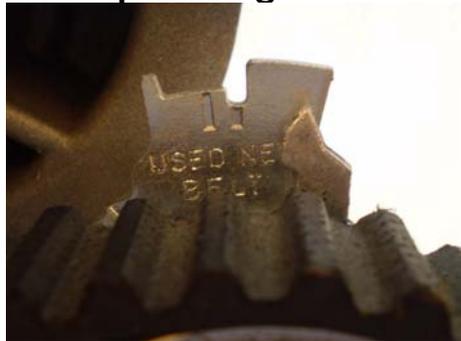
Full stop setting

When tensioning, the adjusting cam is to be turned **counterclockwise** (to the left). The timing belt drive must be rotated **2x** by hand with **fully tensioned** tension pulley. Only **after this has been done** is the tension to be set by **turning the cam to the right** to the "new" mark.

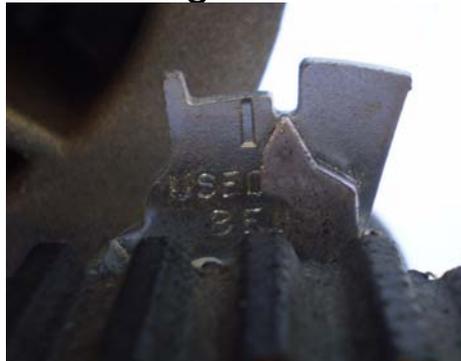
Final setting
