Technical *Info*

Change of idler pulley CT 975 K1 to CT 975 K3 - Opel 1.6 / 1.8 16 V

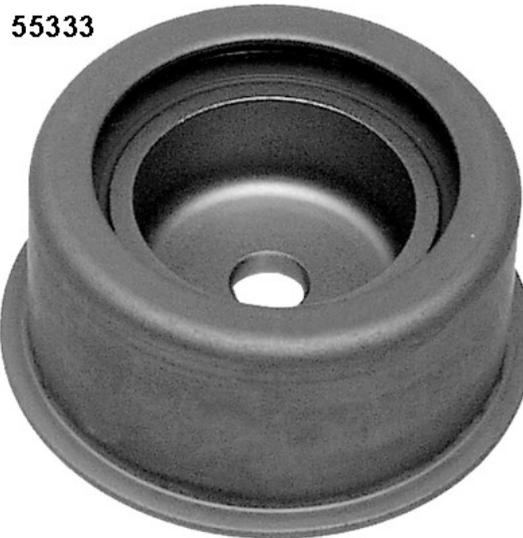
Fig. 1
Pulley to be replaced

The idler pulley included in the kit for the type delivered is different to the one installed in the vehicle.

According to the manufacturer, the new pulley with plastic barrel jacket (55373) must be installed when the belt is changed instead of the previous metal version (55333).

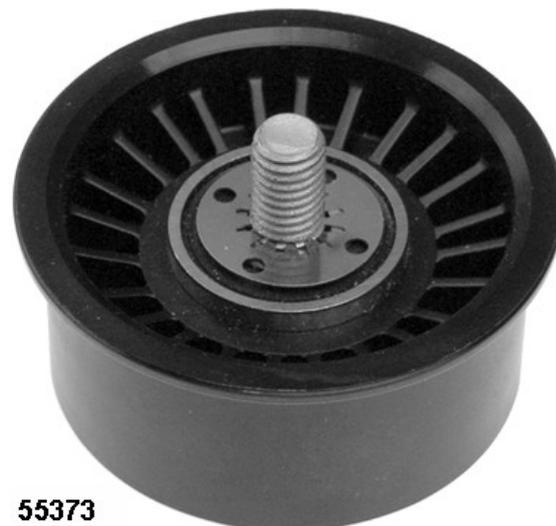
Fig. 2
New idler roller

The new pulley is now equipped with a pre-mounted bolt and can be used directly.
