Blue Print ADBP990021

Toyota Land Cruiser (URJ20*), Sequoia (UPK60, USK6*),

Engine: 1UR-FE, 3UR-FBE, 3UR-FE

Oil Filter Housing Cap

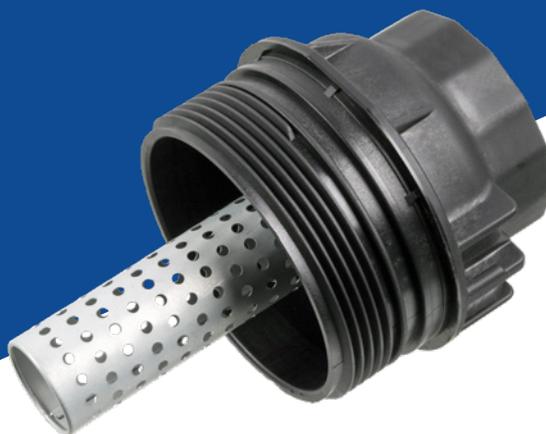
The low oil pressure lamp is illuminated and the vehicle loses power, as well as becoming noisier in operation.

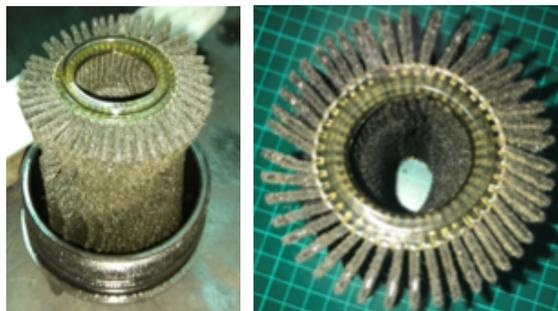
It is possible for the central perforated support tube to become detached from the cap when removing the old oil filter. If this goes unnoticed it will result in the oil filter collapsing inwardly - reducing the oil flow to the engine and potentially causing catastrophic engine damage.

Before fitting a new oil filter element (ADT32126), check to make sure that the perforated support tube is securely attached to the oil filter housing cap. If it is missing or loose, replace the cap. Remember to lubricate the O-ring seal with clean engine oil before fitment and tighten the cap to 25Nm.
