Various Hyundai and Kia models

Tensioner Pulley for Timing Belt

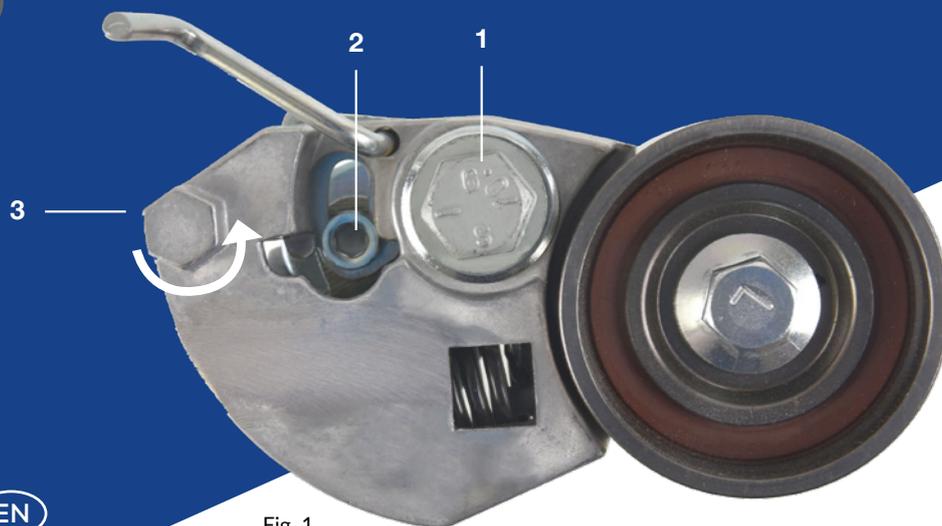
Fig. 1

This timing belt tensioner needs to be set correctly during the installation process. If this is not followed, this can cause the timing belt system to fail.

Removing the load pin too early influences the operation of the tensioner dramatically, which leads to premature failure and to possible engine damage.

Fig.1 Install the new tensioner and tighten the installation bolt (1) to 55–60 Nm.

Loosen the Allen key bolt (2).

Turn the tensioner counter-clockwise using the hexagonal shape. (3)

Slowly turn the engine two revolutions clockwise.
