WATER PUMP INSTALLATION

For CP3358, CP2424 and CP3384

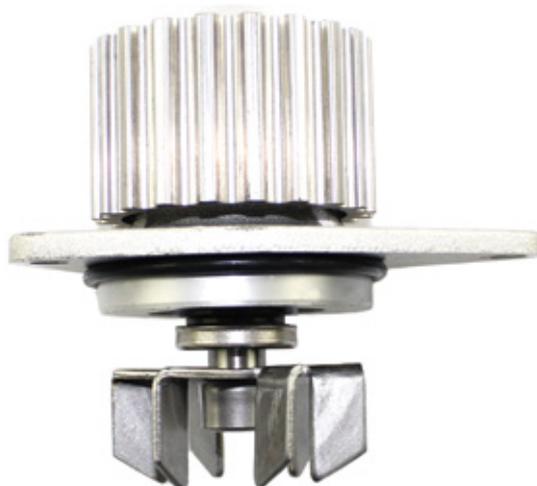
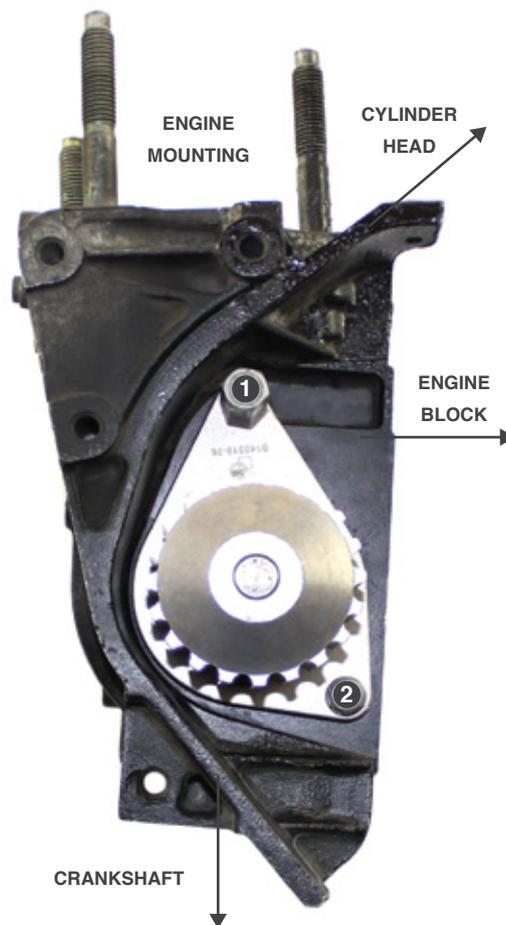
Incorrect fitment of these Water Pumps may lead to one of the following symptoms:

- Damaged casting.
- Leaking during start up and past the O-ring.
- Timing Belt running off the Drive Pulley resulting in engine damage.

Misalignment of these BGA Water Pumps are common due to the limited access within the PSA engine bay.

- Ensure the engine housing is clear of contamination.
- Silicone Sealant is not required and if used it restricts the compression set and alignment of the NBR O-ring, resulting in premature failure.
- The BGA Water Pump body must be square to the housing before installing the mounting Bolts.
- Finger tight both Bolts and ensure the BGA Water Pump rotates freely.
- Tighten the Bolts in the following sequence and to the manufacturers torque specifications:

① 12mm

② 10mm

- Finally make sure the BGA Water Pump rotates freely.
