SI 1542
For technical personnel only!
1/1

SERVICE INFORMATION

REGULATING THROTTLE: DAMAGE CAUSED BY CORROSION

ON BOXER, DAILY, DUCATO AND JUMPER

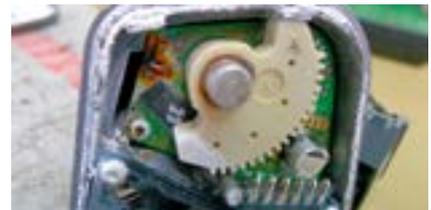
On the vehicles listed above, water or moisture may infiltrate through the coupling of the connecting cable. This moisture may cause severe damage in the interior of the regulating throttle, leading to eventual failure.

View of the interior of a damaged regulating throttle

Check whether there are visible traces of corrosion or moisture on the built-in plug of the regulating throttle or on the cable coupling. If this is the case, replace the regulating throttle and cable.

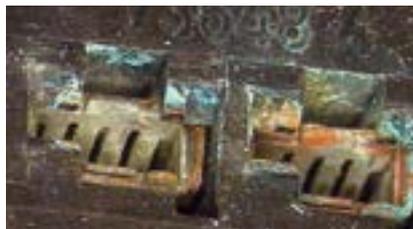
Coupling with traces of moisture and corrosion

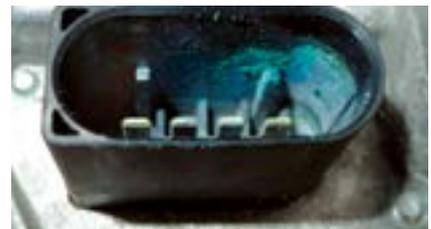
Built-in plug with traces of corrosion

The regulating throttle 7523D installed until 2009 can be replaced by the Pierburg regulating throttle 7.01754.10.0 using the adapter cable 4.07360.49.0. The adapter cable is sealed to protect against moisture.
