VKM 31012 – VKMA 31014

Technical Bulletin - January 2012

AUDI, SEAT, SKODA, VW

Fitting recommendations

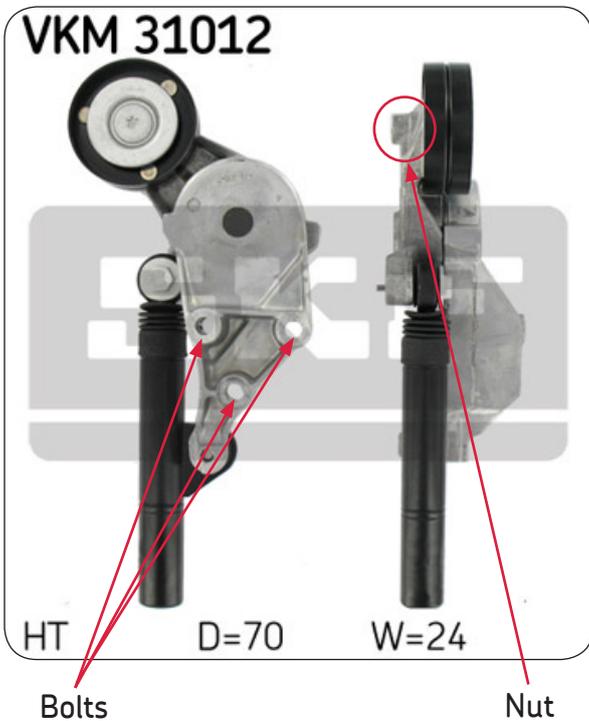
On the above listed applications; the VKM 31012 auxiliary tensioner casting could break close to the lower fixing point of the hydraulic piston. The likely root causes for this could be:

- A worn free alternator pulley (FAP).
- Low-cost, replacement alternators equipped with a simple solid pulley.
- Vehicle applications listed before 07/1998, equipped with a solid alternator pulley.

In the above 3 cases, the tensioner tries to compensate for the missing FAP function and is subjected to excessive vibration. The tensioner has not been designed to work in such extreme conditions and therefore the tensioner bracket breaks close to the hydraulic piston lower mount.

SKF strongly recommends changing the complete accessory system – the SKF kits listed below include the accessory belt, tensioner and FAP:

- VKMAF 31014-1: VKMA 31014 + FAP VKM 03101
- VKMAF 31014-2: VKMA 31014 + FAP VKM 03100
