febi 36070

Various Citroën, Fiat, Ford, Lancia, Landrover, Mitsubishi, and Peugeot models

Part Description: Magnet Wheel for Crankshaft

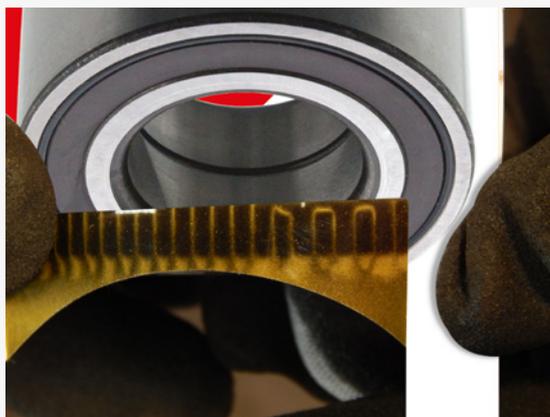
Example of a faulty reluctor using a magnetic test card

A magnetic reluctor is extremely sensitive to any cleaning or handling. As a result, it may become faulty which can lead to an incorrect crankshaft sensor speed signal. This can result in an engine management malfunction with a fault being logged, such as fault code P0336. (An example of a faulty reluctor with damaged magnetic segments is found above). febi recommends replacing the crankshaft magnetic reluctor wheel at the same time as the routine replacement of the timing belt and/or the torsion vibration damper (TVD) pulley.

febi offers this part singularly or as part of a kit to include the TVD and bolt (36433 or 106476). This combination kit enables a professional repair and avoids potential complaints. This saves time and money for both workshop and customer!
