febi 45956

Volkswagen, Audi, Seat & Skoda
various models

Timing Chain Kit and Camshaft Bracket

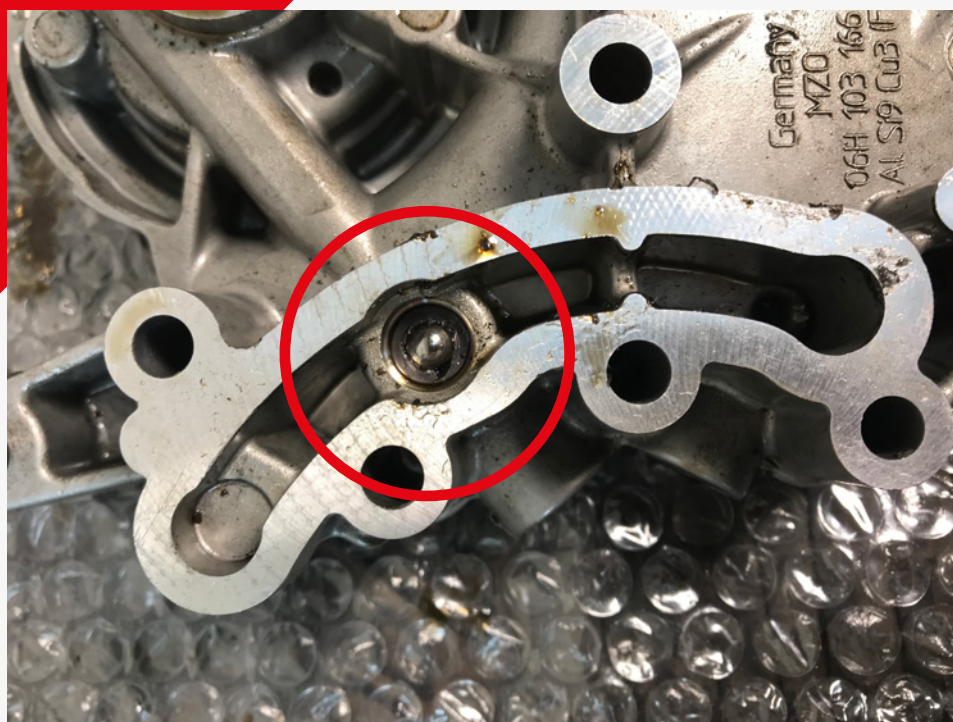
Figure 1

If the data is reading over 5 degrees at idle or during a snap wide open throttle test then the screen for the oil non return valve, located in the camshaft adjuster bracket has come apart and lodged itself within the camshaft adjuster spool valve and the intake camshaft adjuster (Fig 1).

If the oil screen is present and the mechanical timing is correct, inspect the intake camshaft spool valve, for damage or if the end of the valve has come apart, resulting in a portion of the spool valve being left in the adjuster bore.

Replace the timing chain kit, camshaft adjuster bracket, intake camshaft and the spool valve adjuster.

Follow the vehicle manufacturer's procedures during the inspection and replacement. It is recommended to replace the engine oil and filter as part of the repair.
