SWAG 62 94 7947

Various Peugeot/Citroën/DS, Vauxhall/Opel and Toyota models fitted with the 1.2-litre three-cylinder engine

Timing Belt

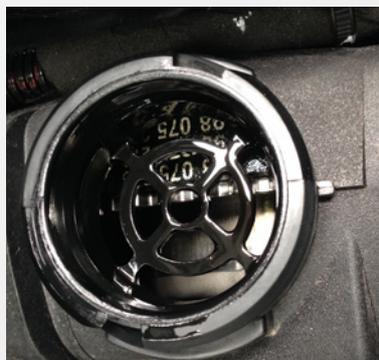
Figure 1

Premature deterioration of the timing belt material can lead to the loss of engine oil pressure and the oil pressure warning lamp showing as illuminated. In addition, fault codes P15A0, P15A1 and P15A8 will be present and logged in the engine control unit.

The 1.2-litre PSA group engine is fitted with a timing belt that runs in oil. In some cases the timing belt material deteriorates during service - leading to a blockage of the engine oil ways. This can cause severe engine damage and/or loss of vacuum assistance to the braking system.

It is important that the vehicle manufacturer's recommended service replacement intervals are regularly checked and adhered to for each model. These essential checks are important as changes have been made to the recommended replacement of the original timing belt during the production period of this engine (subject to make, model and assembly date range). In addition, the timing belt should be visually checked at each service along with the use of the recommended engine oil. (Fig. 1)

If the timing belt material is found to be deteriorating, and the above mentioned fault codes are present, then the engine will require a thorough inspection. The components that are sensitive to being affected are the: engine oil pump strainer, vacuum pump oil filter, variable timing solenoid valve filters and the camshaft bearing caps. Once you have established which parts have been affected (by the timing belt material blocking the oil ways) you should replace as necessary.
