## FAG Service Info

# RIU 566425.# and 566283.#

## Assembly note

Design: Repair Insert Unit (RIU)

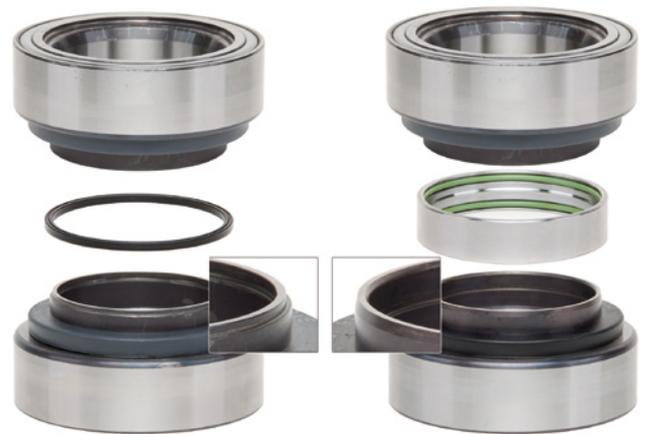
Image 1: The differences between the versions from FAG (left) and the OES (right)

Technical background: On the wheel bearings originally used, two sealing rings (O-rings) are located within a metal ring. These sealing rings are pushed over the two inner rings during assembly. On the repair solution from FAG, the sealing ring is an O-ring that is not held in place by a metal ring.

Instead, the O-ring is placed between the two wheel bearing halves during assembly. This seal still has all of the properties related to its application and is simply a different design variant.
