**Do not disassemble part of EGR valve from manifold. It will cause rejection of potential claim.**

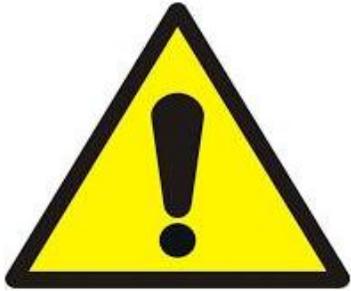
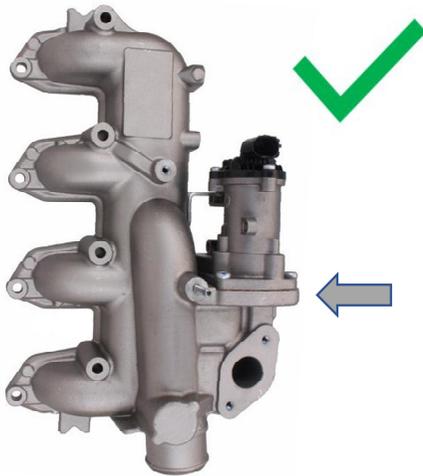
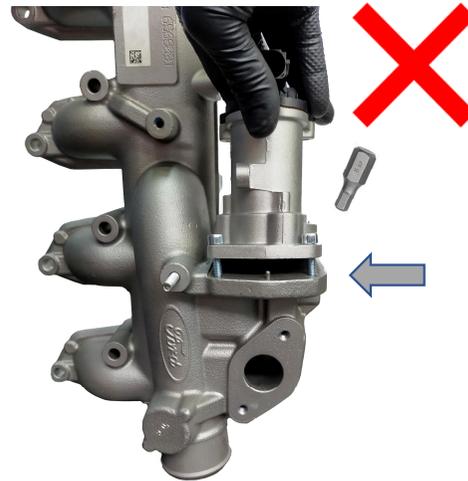
Reason: sealing part of EGR valve is located inside manifold and replacement of top part of valve will not solve the problem if the cause is inside sealing part of EGR valve.
