**SI 0090**  
For technical personnel only!  
1/1

# SERVICE INFORMATION

## ELECTRIC EGR VALVES

MATCHING TO THE ENGINE CONTROLLER IS REQUIRED

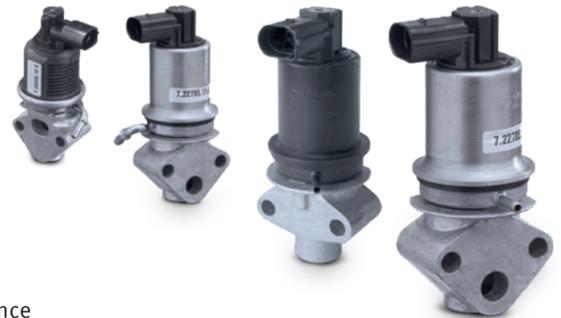
Different electric EGR valves

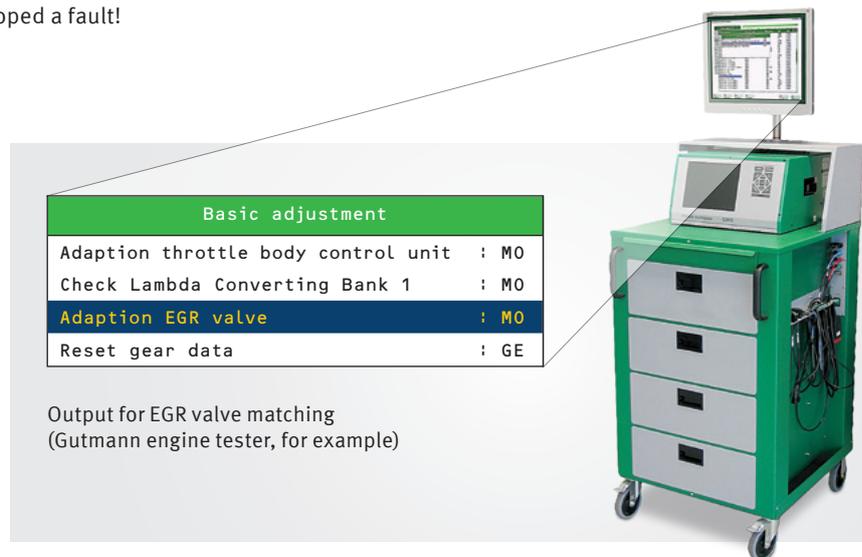
Basic adjustment	
Adaption throttle body control unit	: MO
Check Lambda Converting Bank 1	: MO
Adaption EGR valve	: MO
Reset gear data	: GE

Output for EGR valve matching  
(Gutmann engine tester, for example)

### The electric EGR valve must be adapted to the engine controller!

This is done by selecting a special programme of the engine tester (“default setting”, for example). More information on this is provided in the manual for your engine tester.
