Early failure from heater and radiator by contaminated cooling system after a exchange

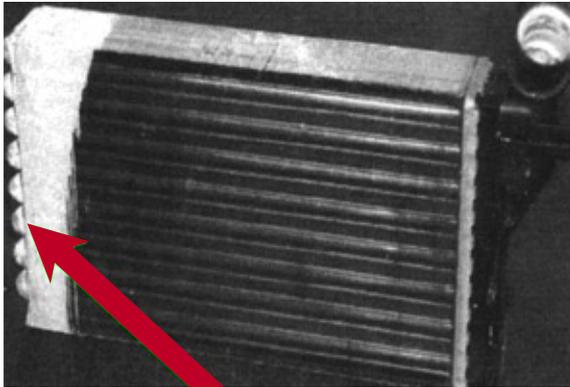
By cars with integrated turbolator heaters the rate of failure by leakage after an exchange increases.

The leakage accumulates mostly in the near of U-arches. Different manufactures researched and find out if the cooling was not cleaned or flashed before the exchange; contaminants will stick on the turbolator and causes an early failure.

Picture 1 shows an absolute permeable heater installed since 9month in a car.

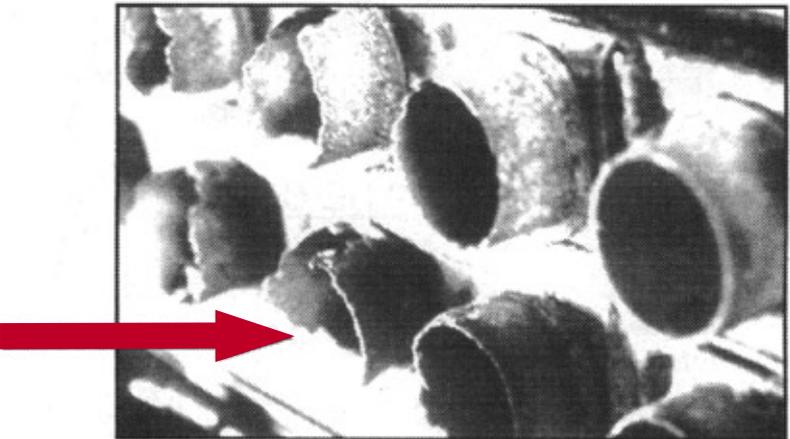
Picture 2 shows a coil of the turbolator. On the upper spiral solid parts accumulate.

Picture 3 shows how the corrosion corrodes aluminium tubes in the cooling block when the cooling system was not efficient cleaned or flashed, or used to less or wrong frost protection.

Picture 4 + 5 (top right) shows the cylinder head top with the affected by using to less or wrong frost protection. The released metallic contaminant circulates in the cooling system and blocks the little openings as the U-arches in the heater.

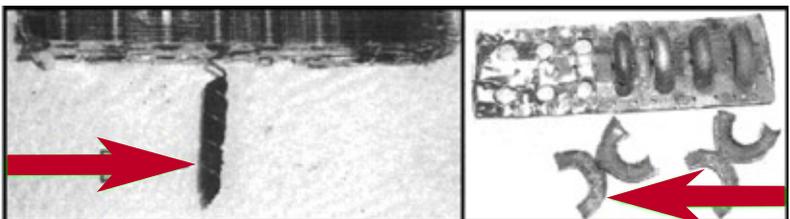
If contaminants accumulate on the turbolator, the corrosion process will interrupt for a short time and the blockage build up higher pressure, which causes a really fine stream of refrigerant under high pressure and creates holes in the U-arches.

Picture 6 (top middle) shows contaminant accumulates to the turbolator which accelerate the corrosion process. Picture 7 (top right) shows any cut open U-arches. Inside the U-arches are visible traces from contaminant.
