febi.Truck

febi 102874

MAN Bus, F90, TGA, TGS, TGX

EGR VALVE

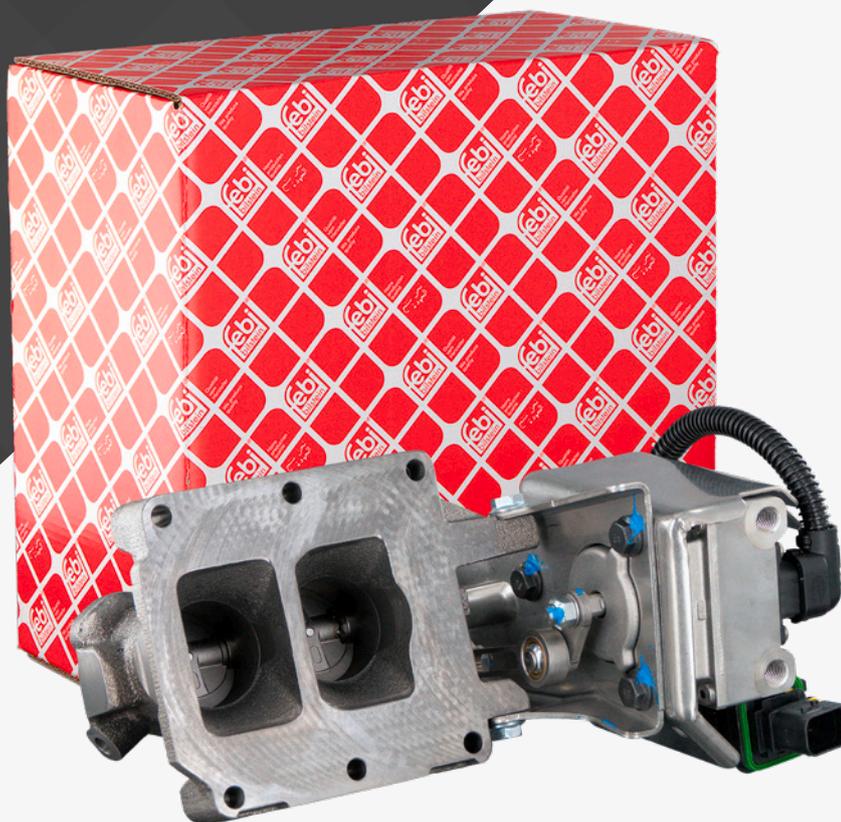
In order to comply with current exhaust emission standards and their limit values, exhaust gas purification systems, such as SCR or exhaust gas recirculation systems, are required. However, problems with the EGR valve are more frequent in exhaust gas recirculation systems. Oil residues and soot deposits can block the valve. In this case, control of the exhaust gas recirculation is only possible to a certain extent or not at all. The warning light for the exhaust system signals to the driver that there is a fault and that a workshop must be visited. Cleaning the EGR valve does not always eliminate the fault. If that is the case, only the exchange remains.

Note: Oil residues and soot deposits are often a result of oil leaks, e.g. on the turbocharger or cylinder head. If these leaks are not repaired, the same problem can occur again after a short time.
